Climate Change Considerations for Trail Managers

Section #1 – Introduction

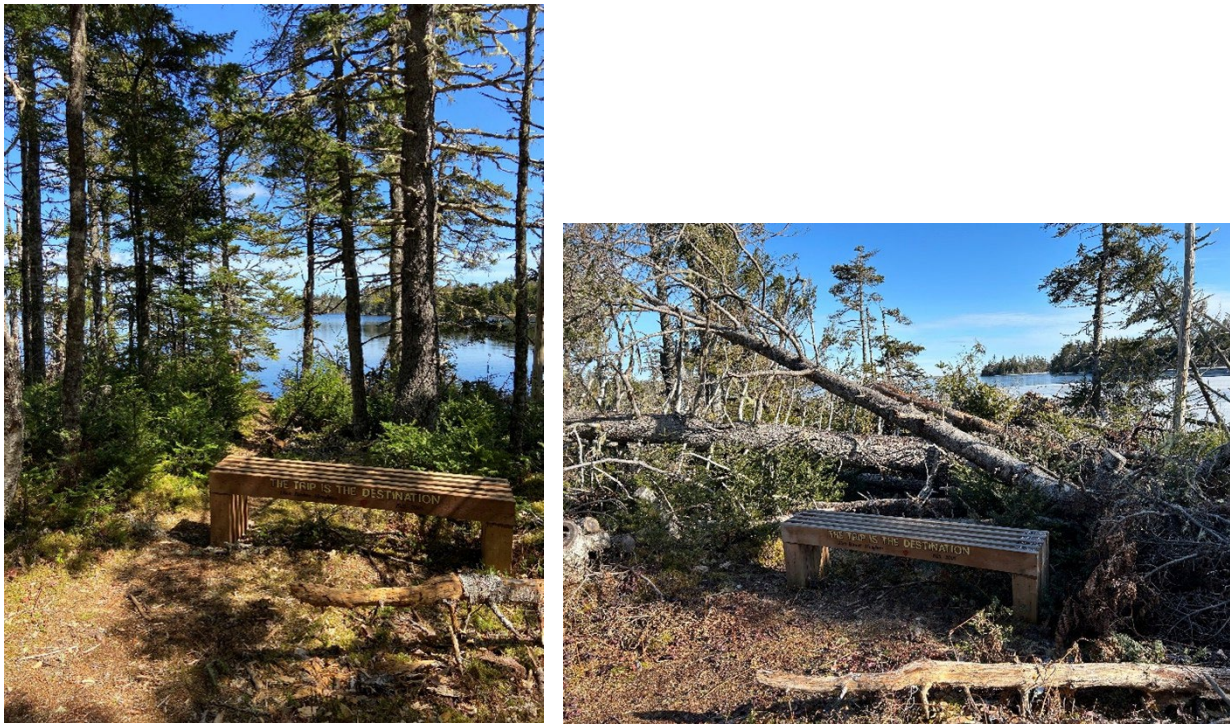
Figure 2: Gull Cove Trail showing rest area pre and post Hurricane Fiona (2022).

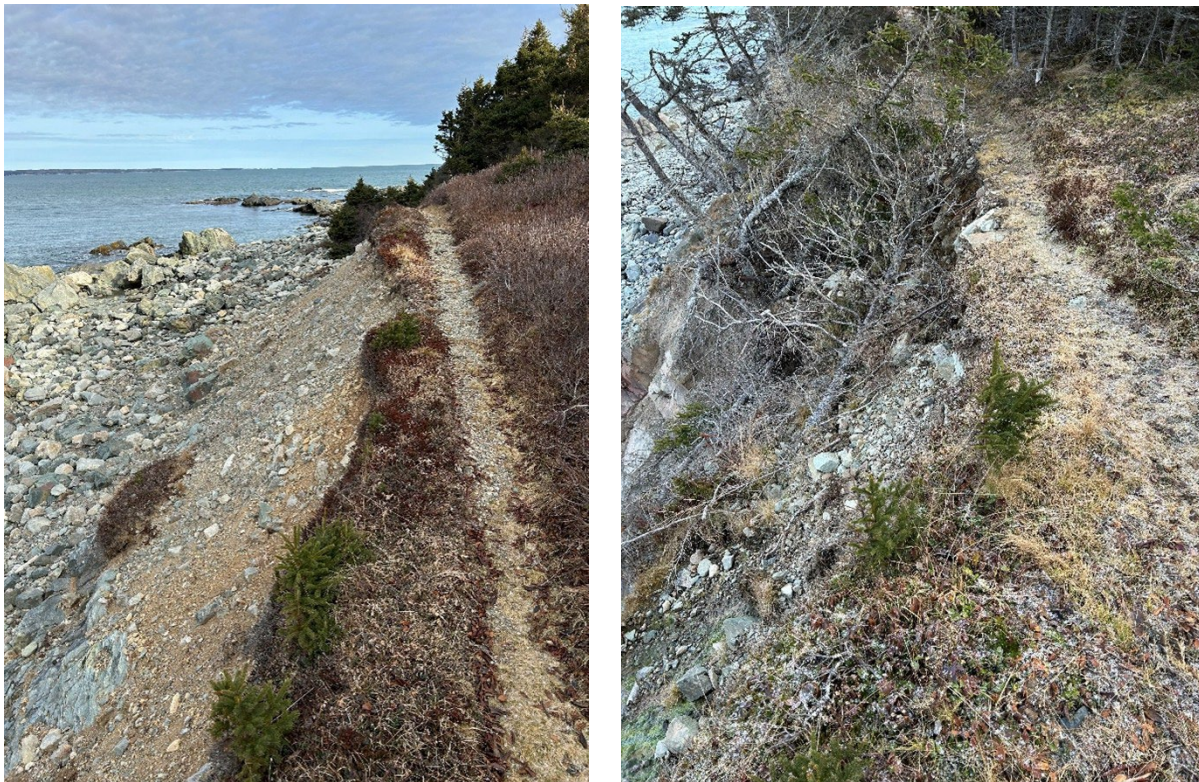
Figure 3: Gull Cove Trail showing coastal trail sections being undercut by coastal erosion (2023)

- Large storms approaching the coastline can generate very high waves that impact shores with tremendous force. The results can include the erosion and undermining of shorelines and damage or destruction of trails and any associated structures and facilities found there. The level of damage inflicted will be even higher when the wave action is accompanied by rising sea levels, storm-generated ocean surge, and/or high tides.

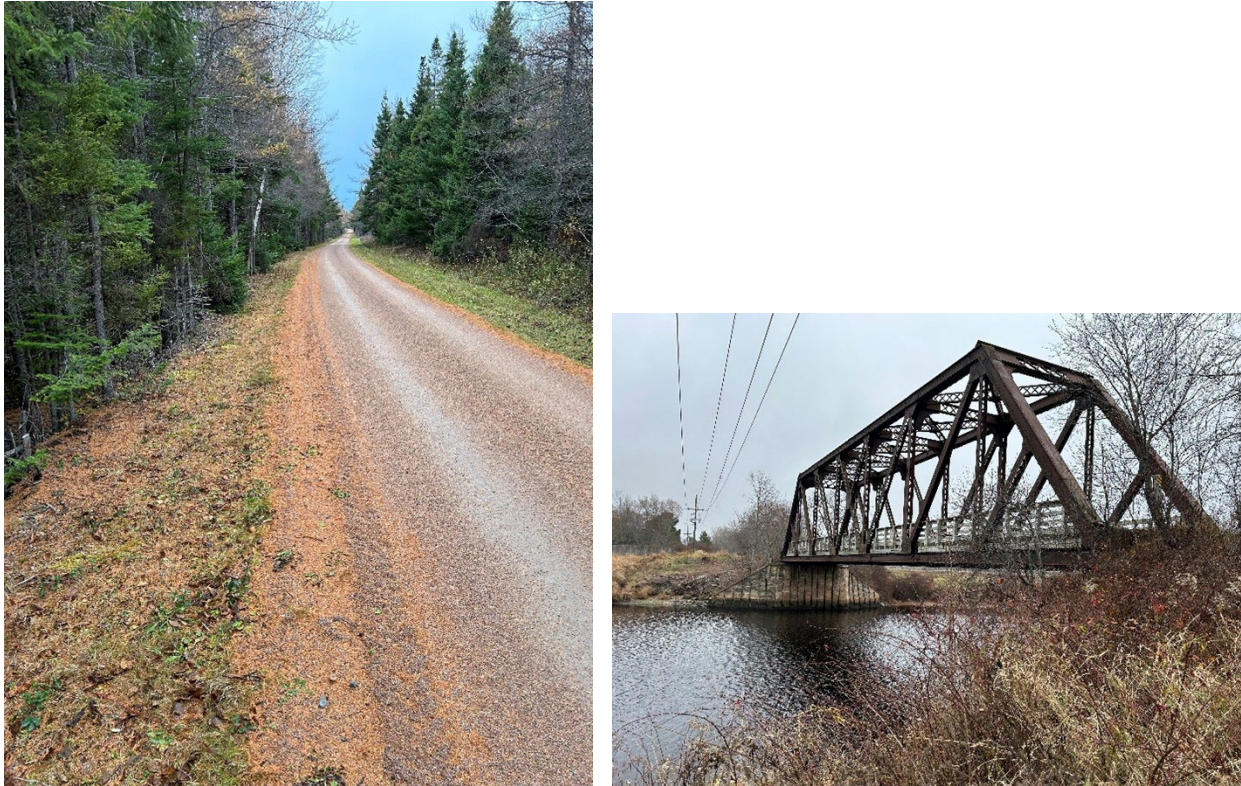
Figure 4: “Rails-to Trails” feature stable trail beds and robust infrastructure.

- **Historic use of the trail alignment:** Many trails in Nova Scotia utilize travel corridors that were originally designed and constructed for other purposes including rail lines, natural resource extraction roads and abandoned public highways (i.e. “k-class” public access roads). These existing travel routes are often selected as recreational trails because trail developers are more likely to acquire landowner permission to utilize them as opposed to constructing all new trails, and the initial financial investment required to make the route “usable” for the intended purpose is often comparatively low. Unfortunately, the current condition, suitability and long-term viability of these routes may be compromised for various reasons including:

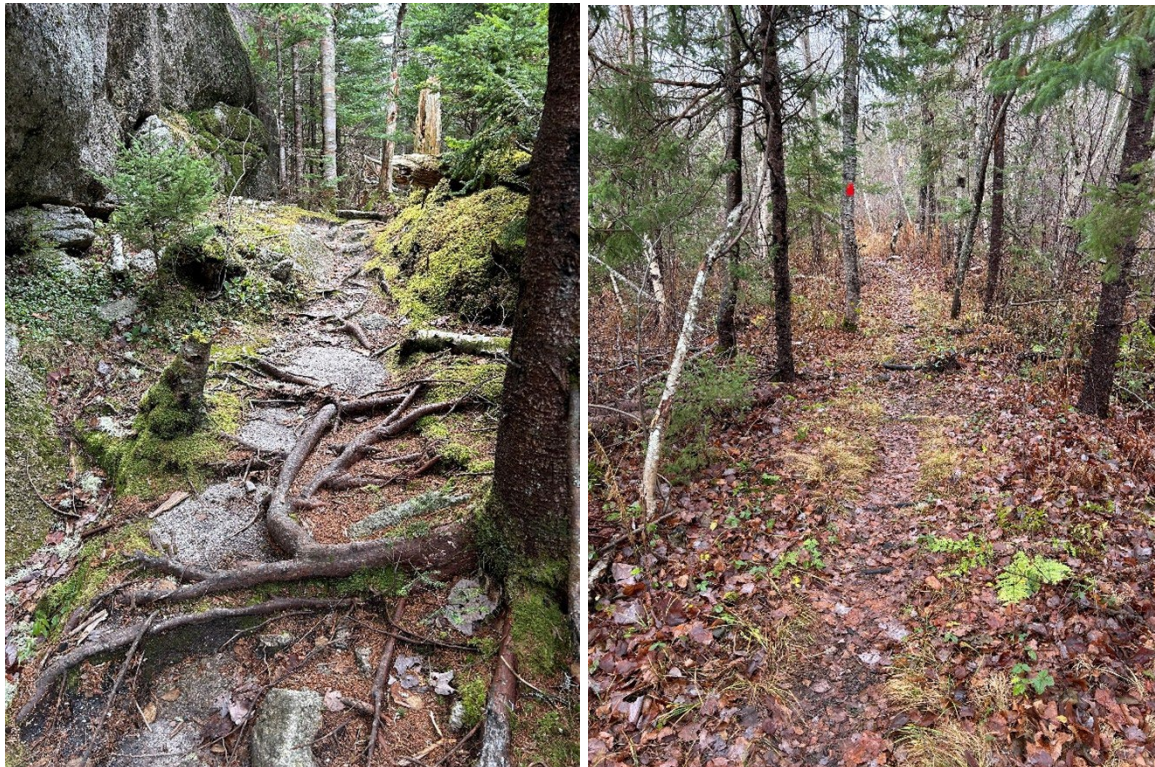
Figure 5: Musquodoboit “wilderness” trails and Pugwash Estuary Trail demonstrating very different topographic and soil characteristics.

- **Soils and bedrock:** Soils and their underlying bedrock are important considerations in trail planning, development and maintenance activities. Soil characteristics vary widely across Nova Scotia, posing differing challenges to trail developers. On one end of the spectrum are landscapes dominated by rock outcrops or coarse rock deposits covered with varying thicknesses of vegetation and organic materials, but with very little mineral soil. While it may be possible to navigate such terrain on foot, it is much more difficult to build a trail surface that can be used by wheeled vehicles. At the other end are deep soils and glacial deposits that provide abundant material for building trails of all types. Soil characteristics will influence trail building strategies, and in the context of climate change and its associated impacts, their importance in building resilient trails becomes even more critical. Those characteristics include:

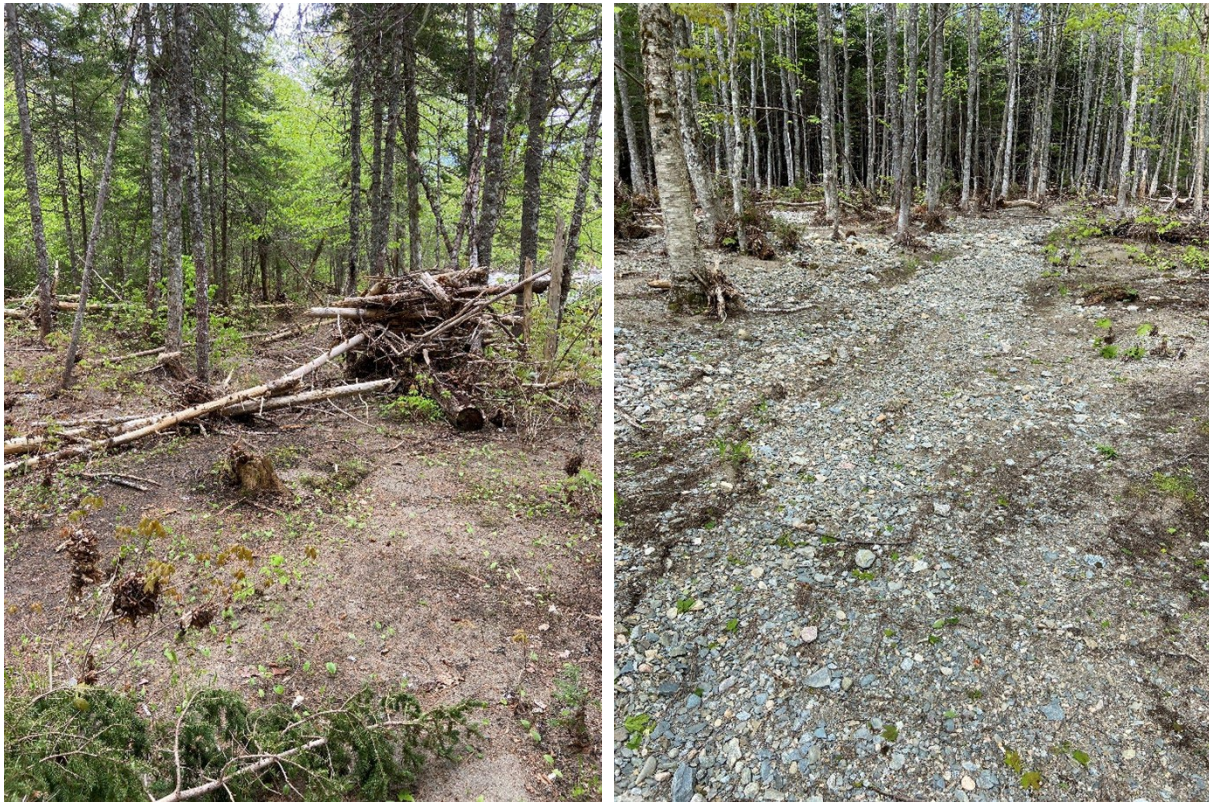
Figure 6: North River Falls Trail showing surface erosion and debris piles in a floodplain zone.

- Floodplains: - People enjoy being able to access water courses as they travel along trails, whether that is the ocean, inland lakes and ponds or streams and rivers. The attraction to water bodies is also manifest in the near universal preference for rest areas, campsites and picnic areas being located near water whenever possible. While these sites offer a unique appreciation of nature’s beauty, heavy rain events and quickly melting snows can transform rivers and streams into dangerous torrents whose waters are capable of exerting tremendous forces and causing immense damage. During such events, many water courses will overflow their banks onto adjacent lands at specific locations along their course. These areas that are periodically, sometimes predictably,

flooded during heavy rains and spring runoff are referred to as floodplains. Floodplains often have a “swept” appearance in the spring after late fall and spring high water has washed away most of the loose leaves and branches. Some of this debris is caught in shrubs and small trees, and can provide some insight into how high the water levels can reach. The periodic flooding adds additional nutrients to these areas making them particularly rich growing areas which often support unique plant communities which may include rarer species. For these reasons, floodplains are not appropriate sites for building trails and related infrastructure.

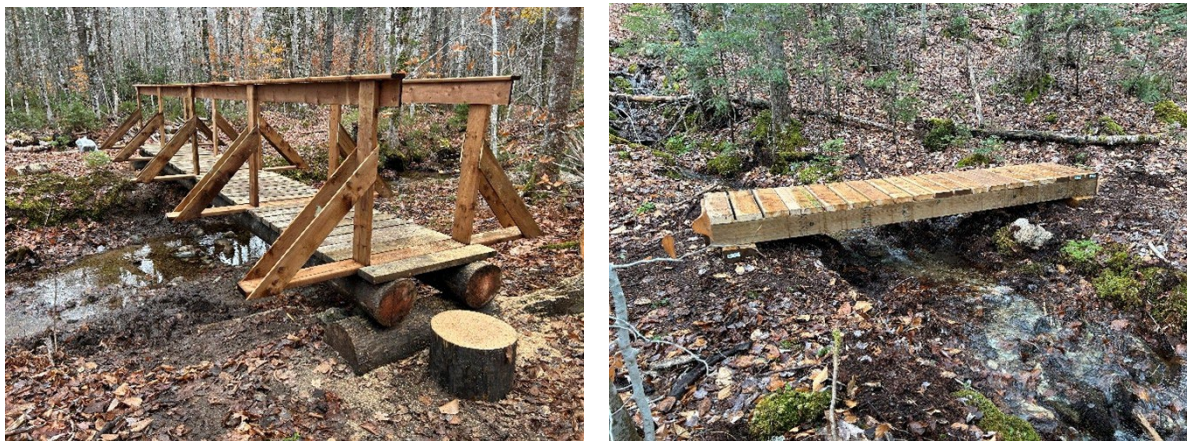
Figure 7: Pedestrian bridge and puncheon spanning watercourses on Little Falls Trail.

- **Stream crossings and adjacent water courses:** Most trail developments of any substantial length will encounter streams that must be crossed using various structures such as bridges, culverts and puncheons depending on the width of the span and the trail type (pedestrian, OHV, etc.). Stream crossings can be costly, and they require ongoing monitoring and maintenance. In the context of climate change impacts, they also represent particularly vulnerable points on the trail and must be managed as such. In best case scenarios, trail developers have the flexibility to select where to install the crossing to take advantage of high stream banks, a straight stream alignment, the absence of a natural flood plain and other factors which help minimize the risk of flood damage. In other cases, the location of the stream crossing has been predetermined and trail managers must make the best of a less-than-ideal situation. The size and design of stream crossings has largely been based on requirements to accommodate the “100-year storm event”. Climate change requires that trail managers abandon the view of a future massive rain event as a one-in-a-hundred “risk” and anticipate that these storms will happen sooner rather than later and that appropriate planning and adaptive measures must be taken now to make their trails and their stream crossings as resilient as possible when the time does come.

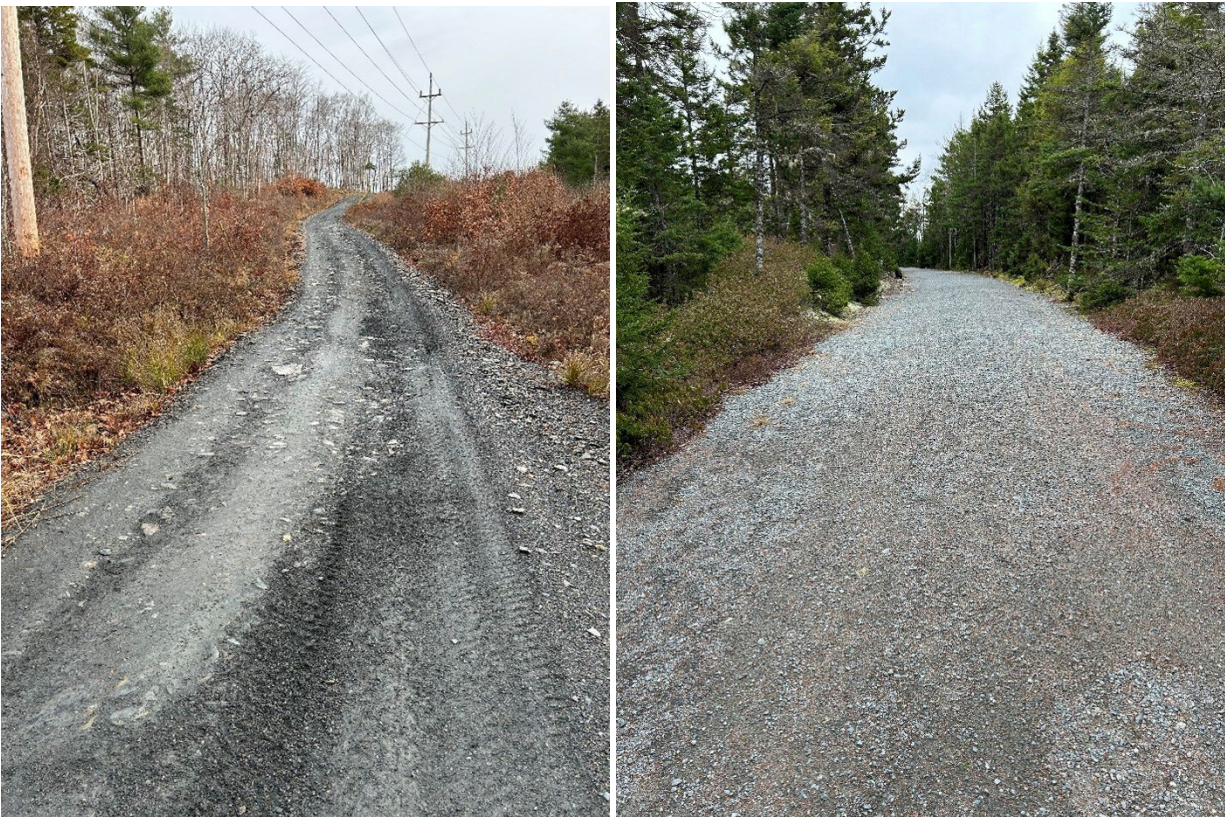
Figure 8: Motorized trails contrasting a graded and crowned travel surface (right) with a rutted and moderately eroded surface (left).

- *Shaping the trail surface:* It is critical that trail surfaces be shaped so as to shed precipitation off to the side(s) of the trail, and not allow it to accumulate and run down the trail resulting in erosion. Wider travel surfaces such as those required for ATV use can be “crowned” so that it is higher in the center and slopes down to either side. Trails having narrower travel surfaces such as back-country pedestrian trails can simply be sloped (5 %) towards the “downhill” side of the trail or the side facing the ditch (if present). Trail usage and the associated wear will change the shape of the trail surface over time, and so grading of the trail to restore the desired shape should be a key component of maintenance programs. This is particularly true of trails where wheeled vehicles are permitted. Tire traffic will result in rutting of the trail surface, especially during wetter periods. Ruts can retain water on the trail leading to the weakening of the trail surface, and they can channel runoff down sloped portions of the trail, bypassing the ditches and culverts that are in place and causing erosion of the trail surface. Grading trails with tractor blades or more specialized equipment can push material into the ditches and the ends of culverts. Over time this material can restrict water flow if not removed regularly. Grading can also leave a small windrow or berm of material at the edge of the travel surface which can impede precipitation from draining off the trail surface. This may delay drying of the trail surface or erosion of sloping trail sections and so should be removed. When possible, efforts should be made to pull materials back in towards the center of the trail.

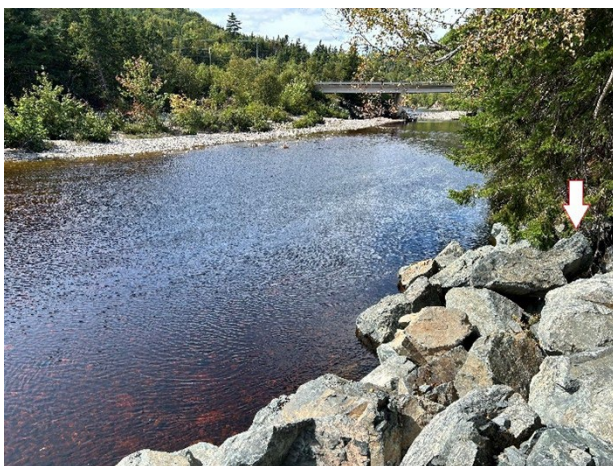
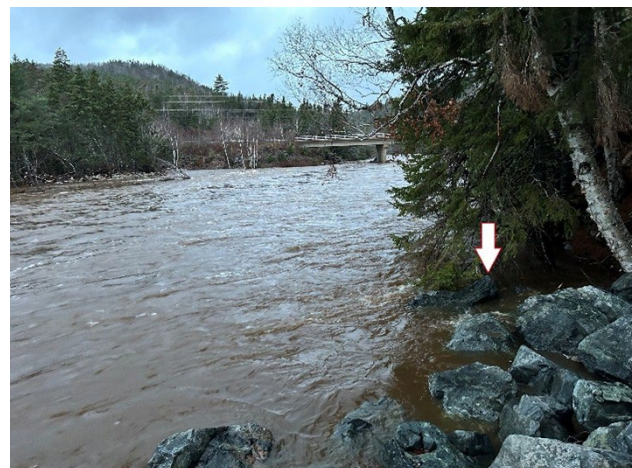
Figure 9: Barachois River near Red Island Trail rose approximately six feet above normal levels after only a 2-inch rainfall. Extensive flooding visible along the opposite shoreline area.

- *Trails located in floodplain areas:* Flooding from nearby watercourses is a major source of damage to trail systems of all kinds, but especially to the larger motorized trails and abandoned rail beds. Streams and rivers can overflow their banks during heavy rain events and/or rapid snow melts. In some cases, this flooding is a regular occurrence, and the area that is impacted can be identified through observation of the event or the telltale signs of water washing over the ground leaving it with a “swept” appearance. Debris can often be seen left in piles or berms along the high-water mark or deposited in clumps on low branches and at the base of trees. The width of a floodplain can vary but is generally widest where the banks of the watercourse are low and the adjacent land is flat. Some floodplains contain what looks like dry or partially dry stream channels, but during flood periods, these channels can fill with the overflow from the adjacent watercourse. Ideally, trails should not be built on floodplains as the forces that are exerted by floodwaters can be difficult, if not impossible to control. Where trails encroach upon floodplains, trail managers should consider realigning those sections to higher ground if possible. In cases where avoidance is not an option, trail surfaces can be built up higher than anticipated flood levels, and the sides of the trail can be strengthened by maintaining vegetation and tree cover or by placing armour stone or other reinforcements. When a built-up trail bed crosses a watercourse and its floodplain, the trail bed can act like a dam restricting the spread of floodwaters and raising the level of the watercourse even higher. To relieve the pressure that floodwaters will exert on the structure that spans the watercourse, culverts can be installed in the bottom of the trail bed to either side of the watercourse to allow floodwaters to flow more freely through the trail bed to areas downstream of the trail.

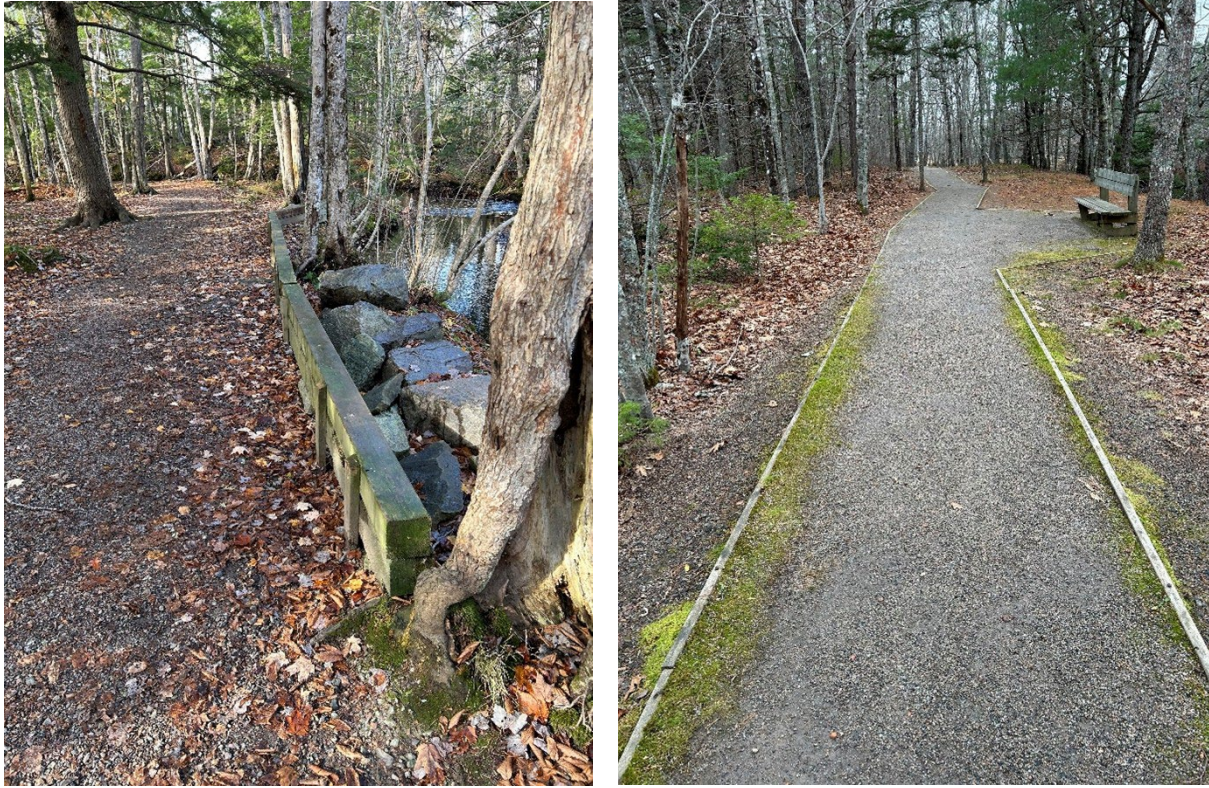
Figure 10: Baille Ard Nature Trail and Old Mill Road Trail provide more accessible trail opportunities.

- **Accessible Trails:** For those recreational enthusiasts with varying levels of mobility, accessible trails are key in providing opportunities to enjoy the many benefits of outdoor spaces. Accessible trails is not a term that applies only to the travel surface of the trail but encompasses all of the associated trail facilities from the parking area and trail head, to posted signage along the trail, and to all structures and buildings. The construction standards for the travel surface of these trails are more demanding than most other trail types, requiring that it be hard and relatively even with slight to moderate slopes. Commonly employed surfaces include boardwalks, hard-packed finer gravels and crusher dust, asphalt and concrete. For dirt surfaces, it is very important that the travel surface be shaped so that precipitation runs off the trail to either side. Water left pooling on the trail will weaken the surface resulting in soft spots and surface erosion. Ideally, the trail bed is built up above the surrounding grade to improve drainage and provide a more even travel surface. Asphalt and concrete provide a more robust and wear resistant travel surface but the use of those materials may be inconsistent with an overall objective of enjoying nature and “natural” settings. Boardwalks built with rot-resistant wood provide a stable, level and elevated travel surface. Wet lumber can be slippery so traction on sloped sections can be improved by surfacing the deck with a coarse material such as roofing shingles. Boardwalks may be the option of choice where soft (e.g. sand beaches) or saturated ground conditions must be crossed. Abandoned rail beds may be one of the best opportunities to create accessible multi-use trails where ability and mobility are nonissues. Accessible trails, because of their more demanding construction standards, may be more difficult to relocate or realign in response to climate change impacts. Therefore, site selection for new trails or identifying existing trails that could be upgraded to accessible trail standards must incorporate climate change impacts in the evaluation process. Ongoing maintenance of accessible trails is also very important as comparatively minor erosion damage caused by runoff from a heavy rain could be a serious obstacle for those with very limited mobility.

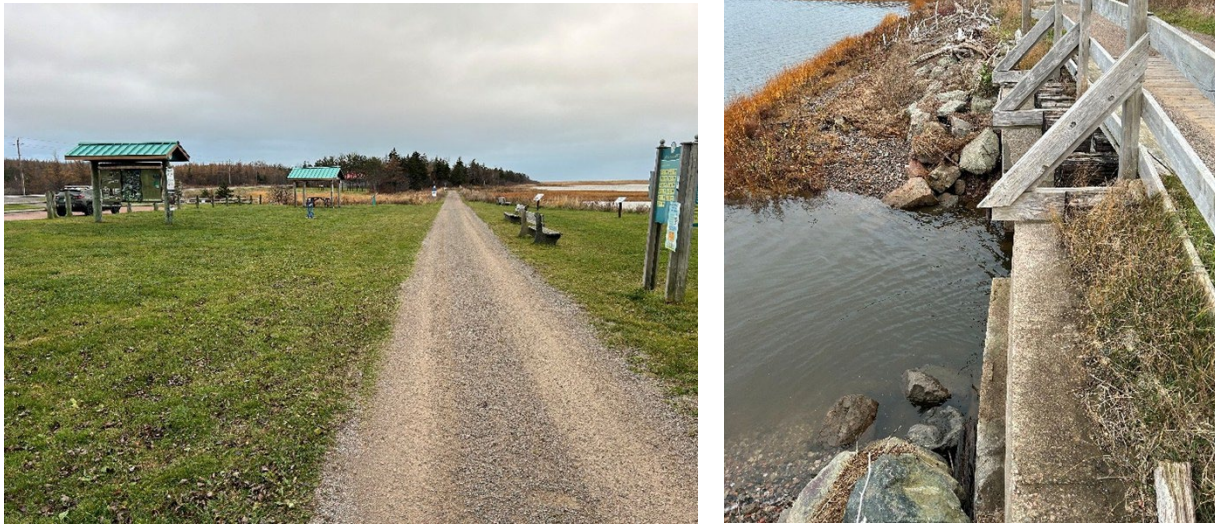
Figure 11: Celtic Shores Coastal Trail showing high water mark (debris line) encroaching on trail surface.

- **Coastal Trails:** Recreational trails located at the coast are most at risk from the damaging effects of climate change. They are often exposed to the full brunt of storms approaching the province from offshore, and those in low-lying areas along the shoreline are also subjected to flooding and erosion from rising sea levels, pounding surf and ocean surge. The Province of Nova Scotia has made available the Coastal Hazard Map (<https://nsgi.novascotia.ca/chm>) which is an interactive mapping tool that highlights those coastal areas in danger of flooding due a combination of sea level rise (“worst case” scenario by 2100) and storm surge at highest tide. This tool helps trail managers to identify trail segments that are at highest risk from these climate change impacts, and investigate options for reinforcing those existing trail sections over time or relocating them inland to more secure areas. Another important consideration for coastal trails is coastline erosion and flooding from storm-generated wave action. The rate of coastal erosion is dependent on a number of factors including the composition of the coastline (erodibility), the exposure to onshore winds and wave action, and the length and steepness of the beach. For example, a coastline comprised by high granite bedrock is much more resistant to erosion than is one characterized by glacial deposits or fractured shales and sandstones. Coastline facing the open Atlantic Ocean to the northeast or southeast would generally receive heavier wave action than shoreline along the Bay of Fundy or the Northumberland Strait. Waves that approach beaches that are long and sloped gradually out to sea tend to dissipate their energy over a longer distance before reaching the coastline, while waves that approach over short beaches that slope steeply out to sea will retain more of their energy as they impact the

coastline. Trail managers should have coastal erosion assessments carried out on trail sections at the coast to determine their vulnerability. Comparing current aerial photos and satellite imagery to past years will give some idea of the changes that have occurred over that time period. Actively eroding coastline can be easily identified in the field and is often characterized by newly exposed soils and rock, slumped piles of ground vegetation or fallen trees along the embankment, exposed root systems, and so on. There are limited options for managing coastal trails and associated infrastructure that are being impacted by flooding and/or coastal erosion. For those on less exposed coastline, building the trail surface up and reinforcing the exposed sides of the trail with something like armour stone may improve its resilience going forward, however, these improvements are expensive and may have to be completed over a number of years and as funding is available. Trails on exposed coastlines that are actively being eroded will likely have to be abandoned or realigned to higher ground inland. The forces exerted by ocean waves driven by high winds are enormous, and the cost to protect trail infrastructure on vulnerable coastline would likely be prohibitive. One of the major challenges of realigning coastal trails inland is to maintain the scenic coastal views and user interactions with the coastal environment that contribute to the overall trail “experience”. This is particularly true where views might be limited by forest cover. As part of the realignment process, consideration should be given to retaining resilient portions of the original alignment, and accessing additional stable sites, whether by routing the main trail to them or utilizing short spur trails out to look-offs or other interesting features along the coastline. One advantage of using short side-trails for this purpose is that unforeseen erosion at those locations will be less likely to cut off the main trail and restrict access to trail sections beyond that point. Coastal trail infrastructure such as signage, benches/tables, kiosks and privies should be built to withstand severe wind events, and located well above the anticipated maximum wave heights. Structures should be robust in construction and secured using concrete pads, sturdy posts, anchor pins or anchor straps. Although locating infrastructure in or near treed areas may provide some shelter from winds, the exact positioning of structures must also take into account the potential damage that might result from windfalls or broken limbs.
